City of Miami Cemetery
Marker and Monument Condition Survey Report
Conducted Winter/Spring 2020

Prepared for
Dade Heritage Trust
190 Southeast 12 Terrace
Miami, FL 33131

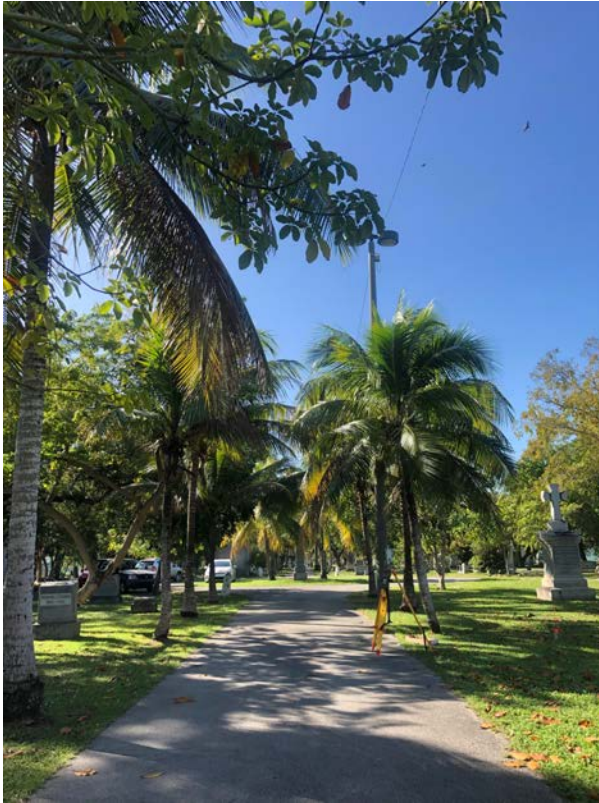
There is one public two-way road that bisects the City of Miami Cemetery. There are two traffic circles that include grave markers and monuments.

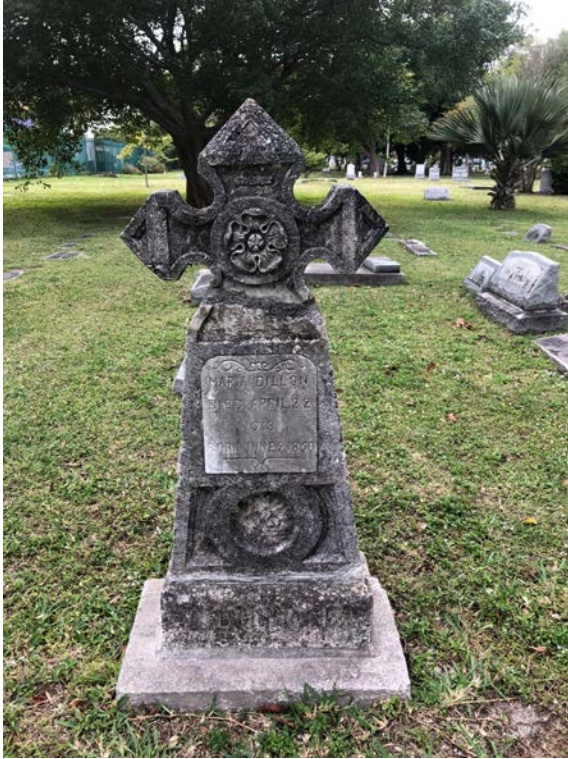
One of the five (5) coral stone (oolitic limestone) markers with a marble plaque. This marker was considered to be in fair condition, but 3 of the other markers require treatment.

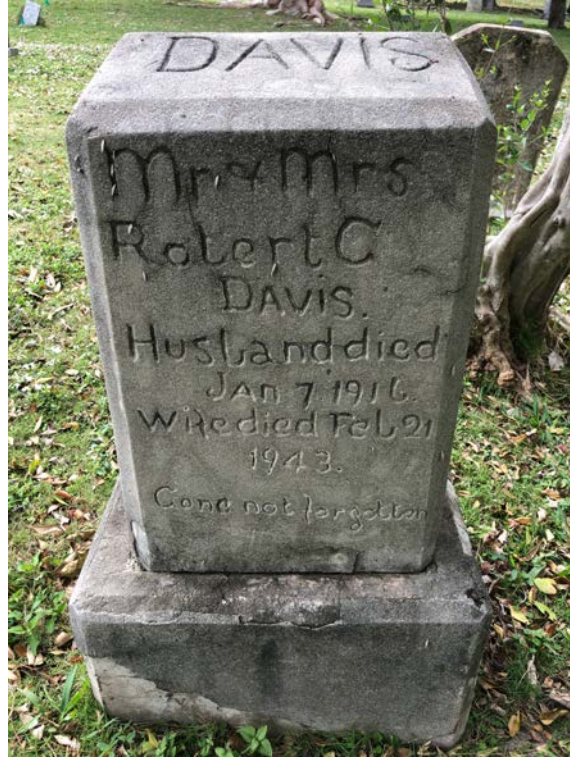
A hand carved marker found in the African American section of the cemetery. There are less than 20 of these hand carved markers.

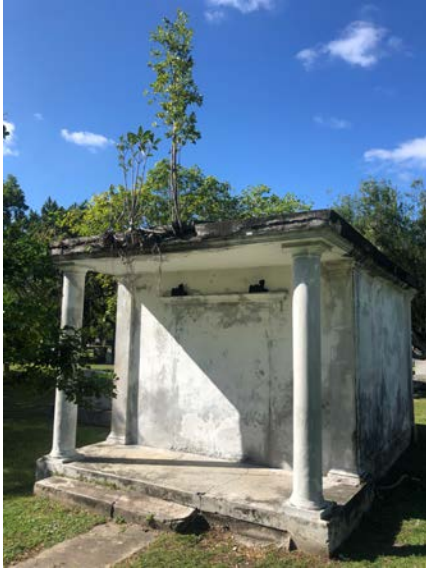
Overall image of the only mausoleum to score a "poor" condition rating. Structural cracks and vegetation put this structure at high risk of continued deterioration and intervention should be prioritized.

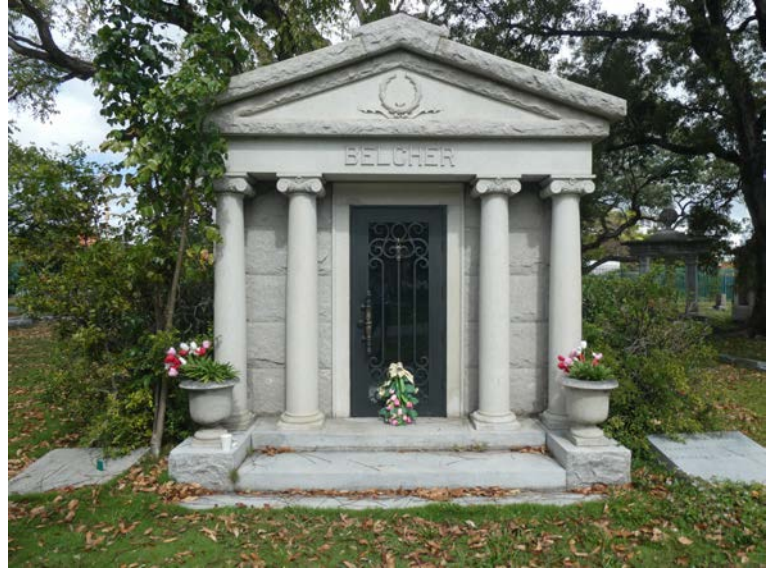
The Belcher mausoleum is that largest mausoleum in the cemetery and is in impeccable condition. It retains a majority, if not all, of its original elements.

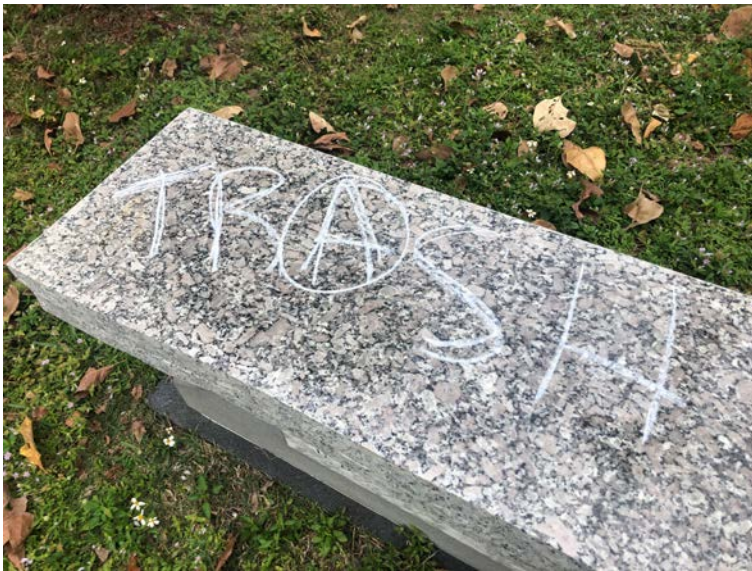
Examples of vandalism on one of the monuments in the Confederate Circle. The cemetery grounds crew promptly acted in removing this graffiti. It is recommended that photographs be taken of such instances prior to treatment and after for documentation purposes.

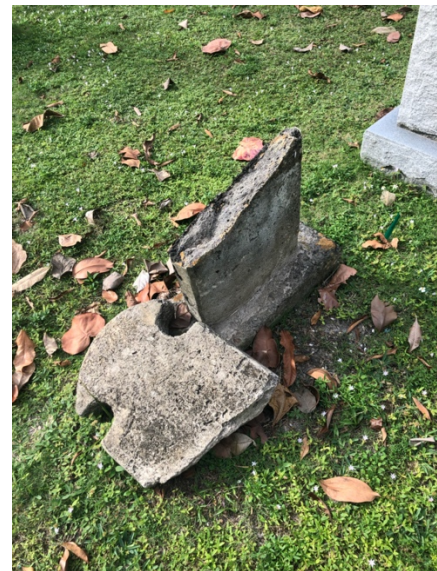
Example of a marker in poor condition but high integrity that should be prioritized when determining an overall treatment approach at the cemetery.

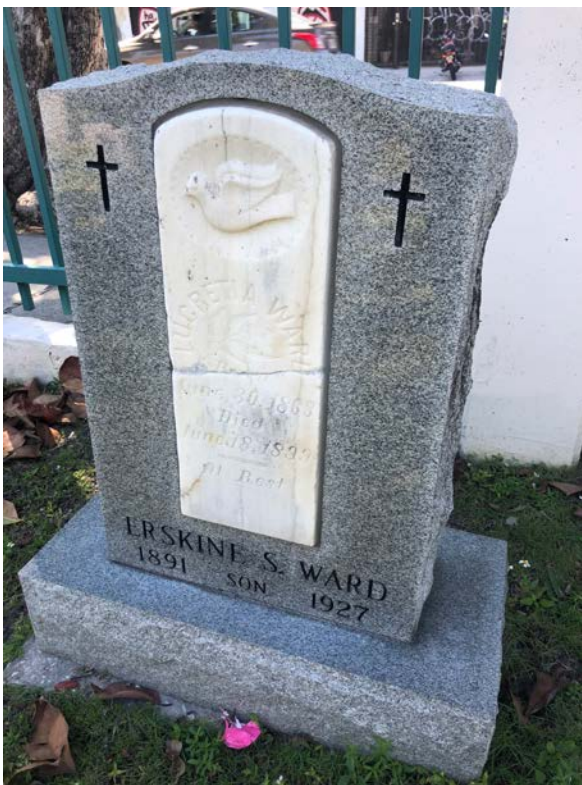
19th century marble grave marker that was conserved by inserted into a modern granite marker. Found on the western boundary of the cemetery.

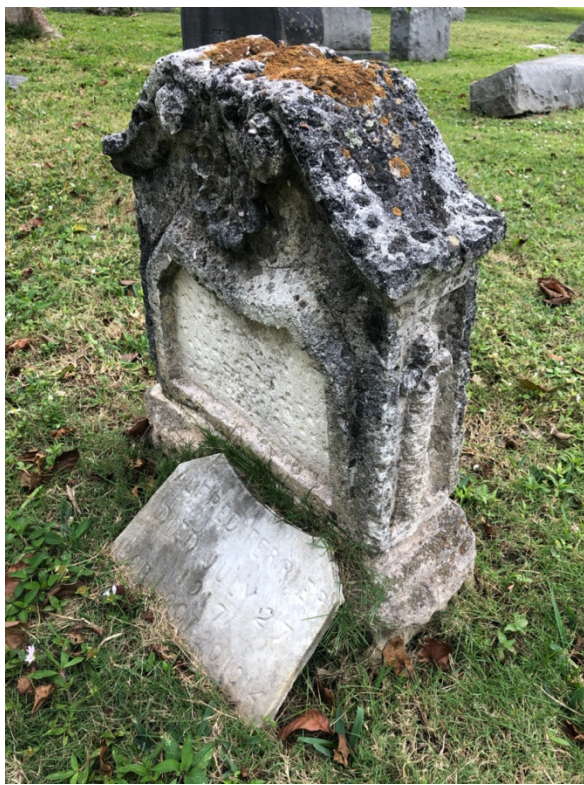
One of the five (5) coral stone (oolitic limestone) markers with its detached marble plaque. This marker should be prioritized when determining overall cemetery treatment priorities due to the uniqueness of the material.
